**[Docket No. FAA-2012-0182; Directorate Identifier 2012-CE-005-AD; Amendment 39-16958; AD 2012-03-52]**

**Airworthiness Directives; Mooney Aviation Company, Inc. (Mooney) Airplanes**

**ACTION:** Final rule; request for comments.

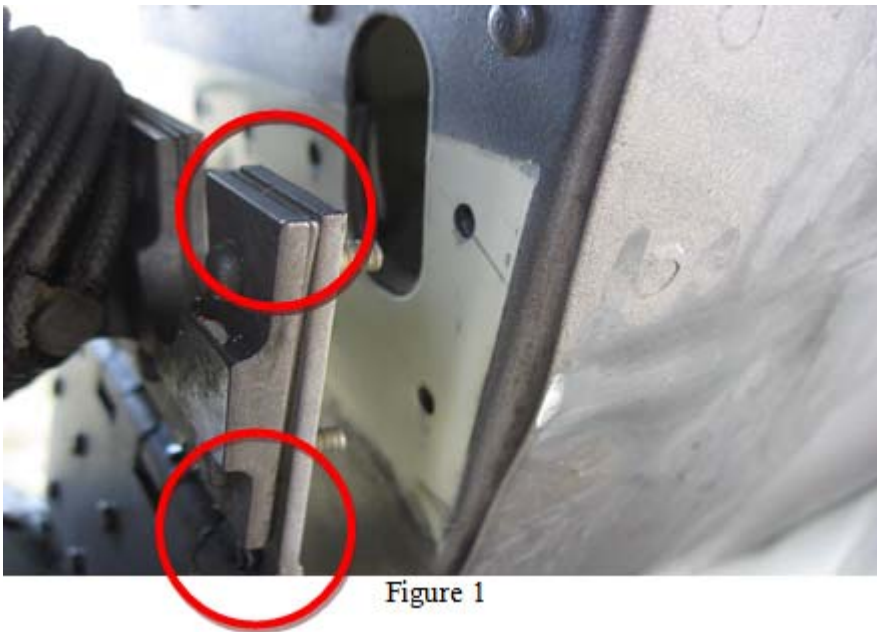
This aircraft was immediately inspected, and all 10 swaged collars that hold the tail trim assembly together had become unattached.

Mooney inspected several other aircraft and found that on one airplane the filler plate was incorrectly installed. The filler plate was not correctly installed between the aft side of the hinge and the bulkhead. Instead, the filler plate was located on the forward side of the hinge between the hinge and trim fitting. It was then noted the incident aircraft had the same issue, as shown in the upper circle of figure 1.

Because the hinge has a lip on the bottom, on the side toward the bulkhead (as shown in the bottom circle of figure 1), if the filler plate is not installed correctly, the hinge will not fit flush against the bulkhead, the Huck Bolt fasteners will not fit perpendicular to the bulkhead, and the collars will not swage properly. The condition also

causes excessive tension pre-load on the Huck Bolts.

The incident aircraft was manufactured in 2008. Mooney has determined the incorrect installation was a manufacturing quality escape during production.

If during the inspection required in paragraph (g) of this AD you find incorrect positioning or improper attachment of the trim fitting, hinge, and filler plate of the tail pitch trim assembly; and/or you find loose or improperly installed Huck Bolt fasteners, before further flight, contact Mooney for FAA-approved repair instructions and perform the repair. Use the contact information found in paragraph (n)(2) of this AD.
